TP 6980E
(02/2009)

Issue 1/2009

Canadian Aviation Service Difficulty Reports

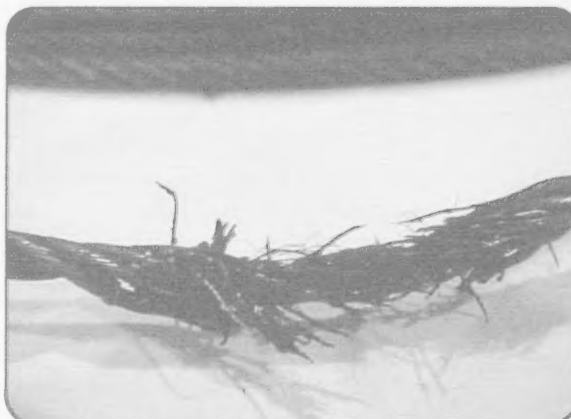
Following flight, a DHC 8 100 operator reported that the aileron controls were stiff (outside air temperature of -20 Celsius). Inspection of the aileron control system revealed a significantly frayed cable at WS 189. Closer examination revealed that 47 strands of cable were broken at a position where the cable crosses a roller fairlead, which was also found to have a seized (sealed) bearing. Both the L/H and R/H aileron quadrants were found to be very stiff and subsequently replaced, along with the defective roller fairlead bearing. The aileron control system is inspected every second C Check or 10,000 hours, which was carried out 7618 hours ago.

Another recent SDR, submitted by a DHC 8 300 operator, who reported that both the L/H and R/H aileron cables were found severely chafed with numerous cable strands completely severed at wing station (WS) 171. The aileron cables are carbon steel and Type 19 X 7 (7 strands with 19 wires on each strand). The L/H cable had approximately 40% of the cable strands frayed. This aircraft had logged some 16000 airframe hours since new. The Type Certificate Holder (TCH) investigated further and noted that cold weather can cause drag on all bearings and pulleys. It was also concluded that these broken cable strands were caused by wear as evidenced by a pointed sharp edge at the strand break location. The cables were found correctly tensioned to 52 pounds; however, an increase of 20% cable tension is recommended for these cold weather operators. An increase in cable tension would provide more positive contact against the aileron pulleys and fairleads and provide more responsive movement from the flight controls.

The principal function of flight control fairleads is to dampen vibration, maintain cable alignment and seal the openings in bulkheads. Deflection of flight control cables in excess of 3 degrees is undesirable. Ideally, a properly rigged airplane will fly straight and level "hands off" at its normal cruising speed. If air currents disturb the stable flight attitude, the aircraft should correct itself, and resume straight and level flight.

During a cable inspection, a cloth or rag should be used to clean accumulated debris from the cable and to catch any frayed cable strands. ✕

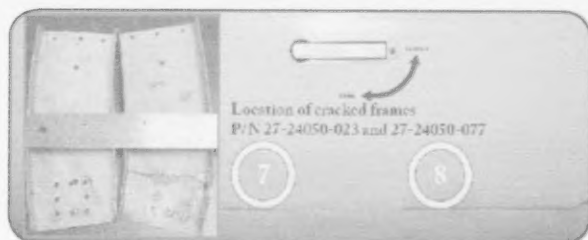
Aging Aircraft, a Great Reason to Look for Cracks**SDR Submitted:**

During an aging aircraft inspection, a crack was detected, visually extending from the lower aft latch (position 8). When the door was removed for repair, further cracks were discovered on the attaching structure for both lower latches (positions 7 and 8).

This failure is believed to be the result of fatigue and if undetected could eventually result in failure of the cargo door. It should also be noted that FAA airworthiness directive (AD) 98-06-25 requires an inspection of the latching system.

Loss of a cargo door could be catastrophic. Ensure your inspections are thorough. ✖

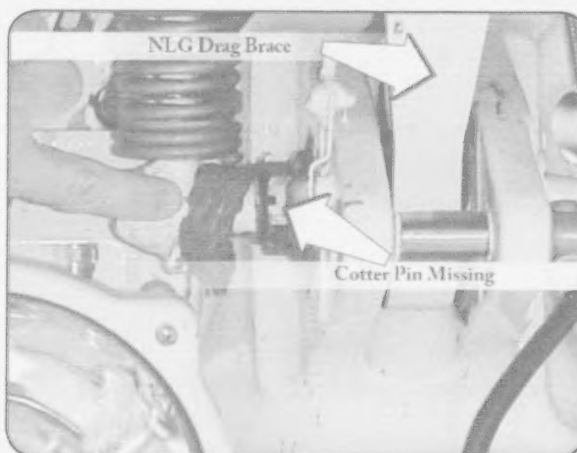
**Missing Safety Device****SDR Submitted:**

During a routine Inspection, an AME discovered that a nut on a lower drag brace attachment hinge pin was not safetied with a cotter pin and the PRC was adrift.

Never assume assemblies are correct because they are new. Inspect all safety devices. ✖

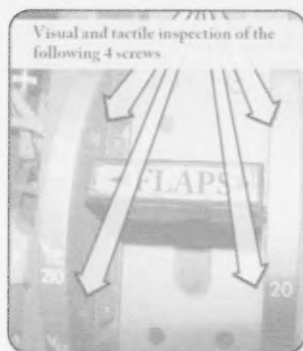
Make Sure your Screws aren't Loose

After takeoff, the crew reported they were unable to retract the flaps from the 10 degree position to the 0 degree position. The preliminary report states that a loose screw was found inside the flap lever guard. The forward right screw located inside the guard was found to be protruding sufficiently to prevent the lever from moving from the 10 degree position to the 0 degree position. All three remaining screws were found to be secure.

A visual and tactile inspection should be performed to ensure that all four (4) screws located inside the flap lever guard are slightly countersunk and do not show any signs of being loose. ✖

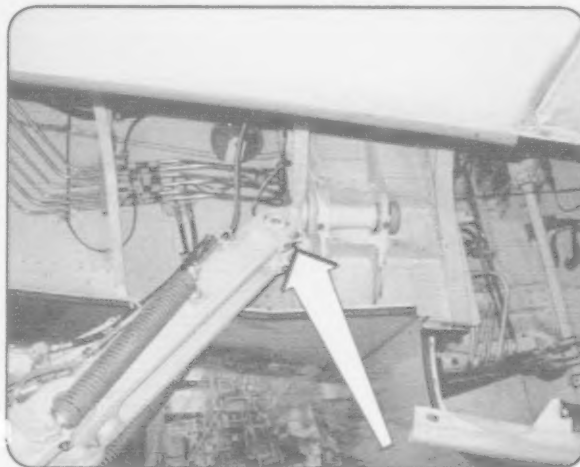
On visual inspection during a C2 check, maintenance found a crank bolt assy bushing on the L/H main gear to have signs of rotation. Both bushings were replaced.

This may be a difficult area to inspect. Be vigilant in areas where grease may hide defects. ✖

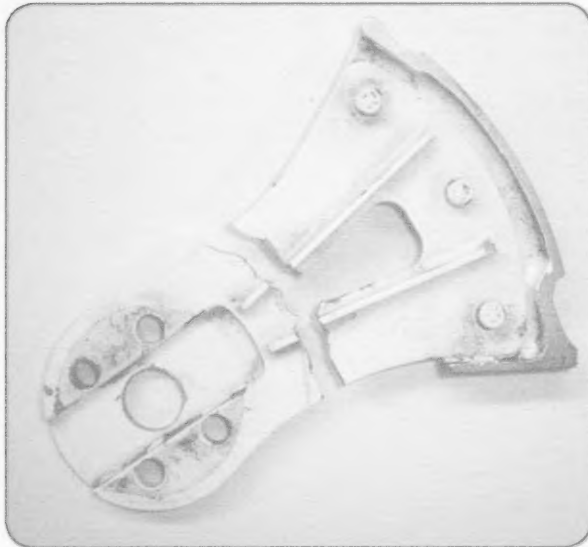
Service Door Up-Lock Mechanism**SDR Submitted:**

Pilot reported that the service door message was displayed. Maintenance personnel were called to investigate the problem. The engineer could not open the door and started removing the door liner. Once removed, they found that the service door up-lock mechanism had broken completely. By looking at the material inside the crack it was noticed there were signs of dirt accumulation in different areas indicating that the crack was not recent.

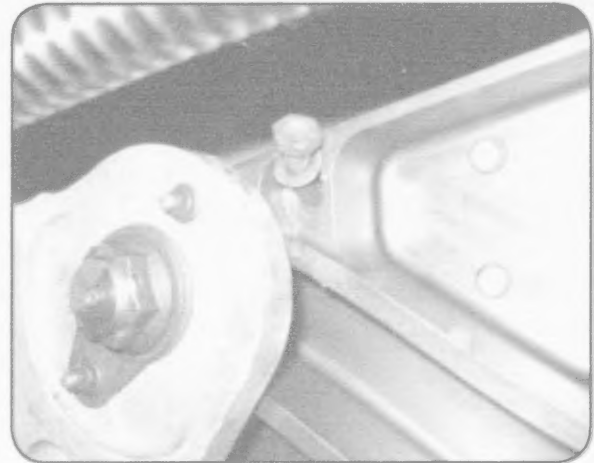
**L/H Inboard Flap Main 1 Carriage Assy****SDR Submitted:**

L/H inboard flap main 1 carriage assy (Part Number (P/N) 190-92001-405) was found grooved on the inside by a loose bolt from the track assy. Embraer advised that the root cause of the damage was caused by a loose bolt in the flap track mechanism.

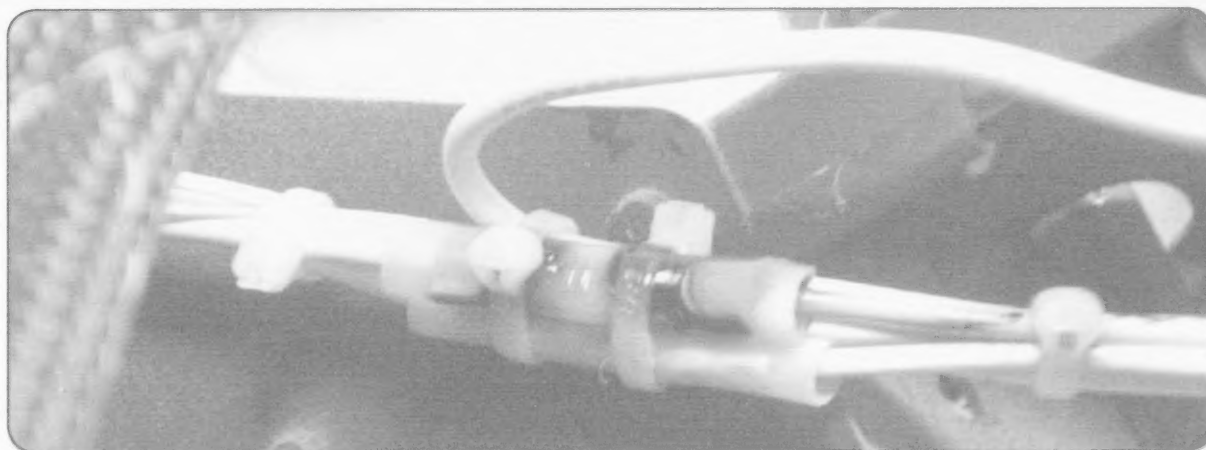
During an unrelated installation of a sat phone system, an amp type splice in the existing aircraft wiring was discovered burnt and discolored. Further inspection indicated that the wiring was for the windshield heat system. Wire No. 1H81A12 was also discolored and burnt; there were no indications of burning in the surrounding area. The burnt splice was found poorly crimped to the wire. When the wire was untied for

repair it fell out of the splice. The adjacent splice was damaged and required replacement. A further inspection found all four splices were improperly crimped. The remainder of the windshield heat wiring inspection was completed and no faults found.

This was a new delivery aircraft with 19 airframe hours. Undetected, this eventually would have become a defect for the windshield heat system resulting in expensive downtime. ✖

The wires 1H83A12, 1H85A12, 1H80B12, 1H81A12 and splices were all replaced and a function test of the windshield heat system completed.

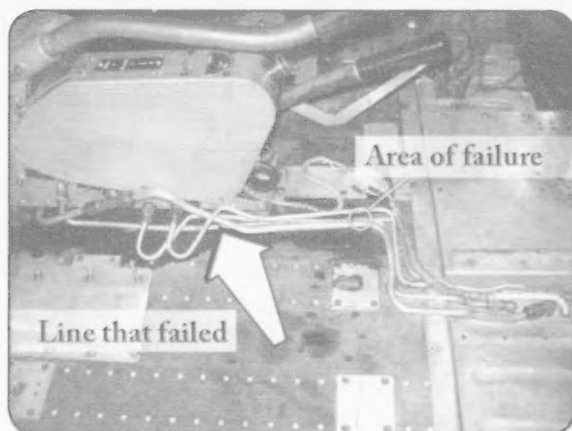
Flash Fire in Cockpit

A turbo beaver was conducting pre-taxi checks in preparation for takeoff when suddenly the hydraulic pump supply line located in the cockpit centre console area developed a pin-hole leak and sprayed atomized hydraulic fluid into the pilot's seat area.

The electrical power wire for the hydraulic pump had arced against the tubing and ignited the atomized hydraulic mist starting a flash fire. Fortunately, the fireball was unable to sustain itself and did not ignite the whole aircraft. The pilot's upper body suffered 1st and 2nd degree burns to his face and right hand. A crewmember who was sitting in the L/H seat did not receive any injuries, thus he was able to extinguish the fire, possibly saving the pilot's life. There was the potential for a more serious event as the aircraft was carrying two drums of fuel at the time of this event.

The SDR submitter stated that the hydraulic system configuration has been in the aircraft since the date of manufacture, but does not match routing shown in the IPC. After a thorough records search (since manufacture) the SDR submitter was unable to find any mention of the lines being replaced or installed. The operator has been in possession of the aircraft since the early 1900's and has never modified or changed the set-up it arrived with.

Subsequently, the operator replaced the affected hydraulic lines in the cabin and installed a fire sleeve to help prevent a reoccurrence. The electrical wire connections were inspected and protected as required.

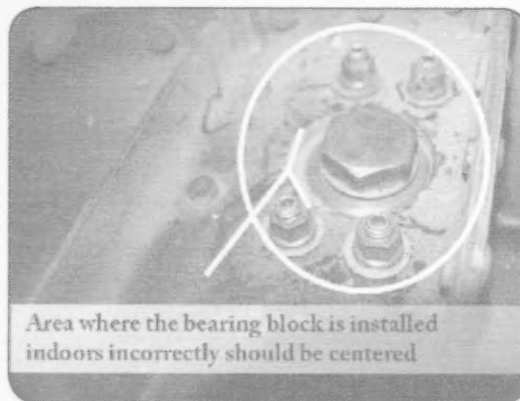
During an inspection on this aircraft, it was discovered that the L/H inboard chord-wise flap rod was rubbing against the span-wise rod. Once the assembly was removed from the aircraft, it was noted that the span-wise rod had a groove worn in it from the other rod. At this time, it was noted that the bellcrank support structure was possibly not situated correctly leading to a lack of clearance between the 2 rods. The defective flap rod was replaced.

Both the “re-lifed wing” assemblies were sent back to the supplier. It was then discovered that the bearing blocks for the bellcrank were not installed correctly thereby causing the chordwise rod to move up slightly when the flaps were deployed.

The bearing blocks were replaced and the aircraft was returned to service.

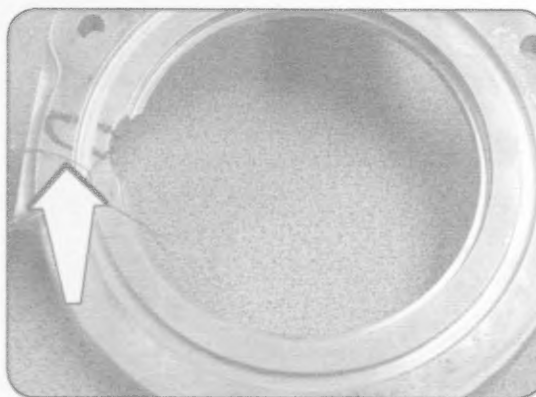
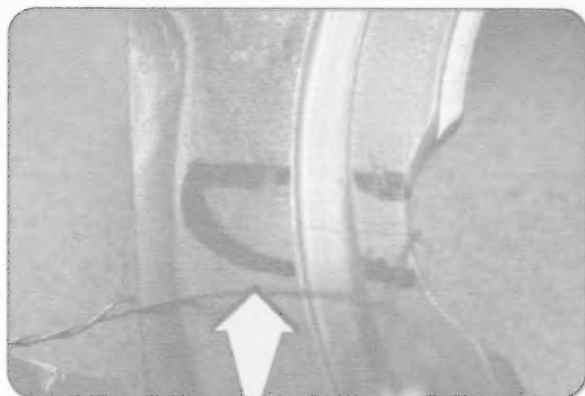
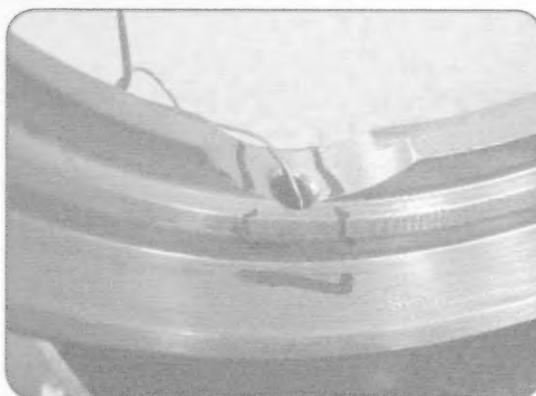
Cracked Pitch Horn Grip

A crack can be seen on the inside of the pitch horn leading from the seal-seating surface to the grip-mating surface. On the inner side where the hole for the relief valve is, the crack is about 1/8 of an inch above the corner where the seal seats all the way through.

The crack can be seen on the inside of the relief valve hole also.

Although this defect was discovered during overhaul, it should be kept in mind while inspecting the hubs in service. ✖

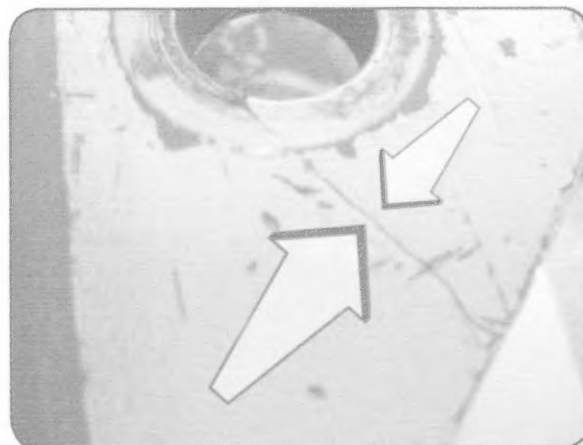
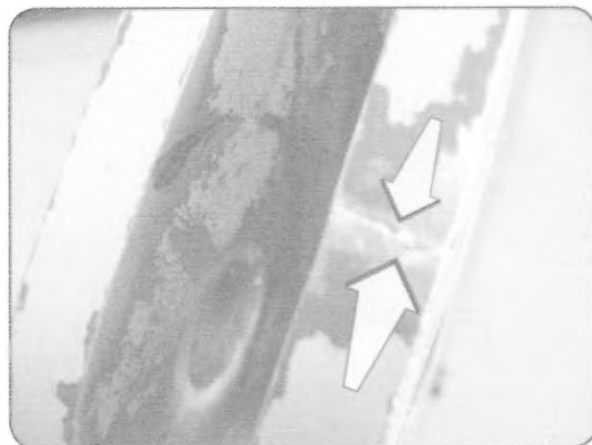
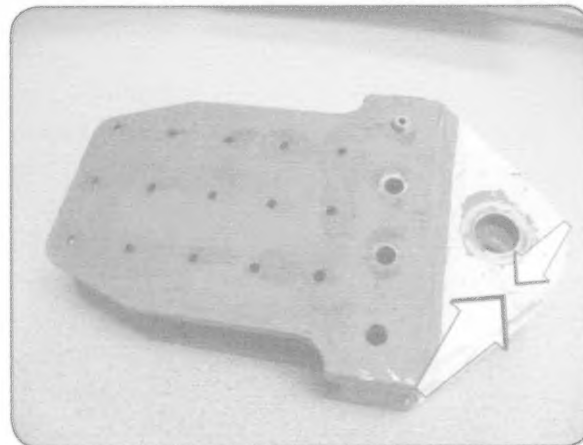
While conducting a 25-hour inspection, a crack was noted on the lift link beam lug. The part was removed and total time of the beam is unknown at this time. The crack was found on the aft ear of the lug on the R/H side.

The SDR database revealed numerous SDRs reporting this defect. Due to the location of the lift link, extra attention is required during inspection. ✖

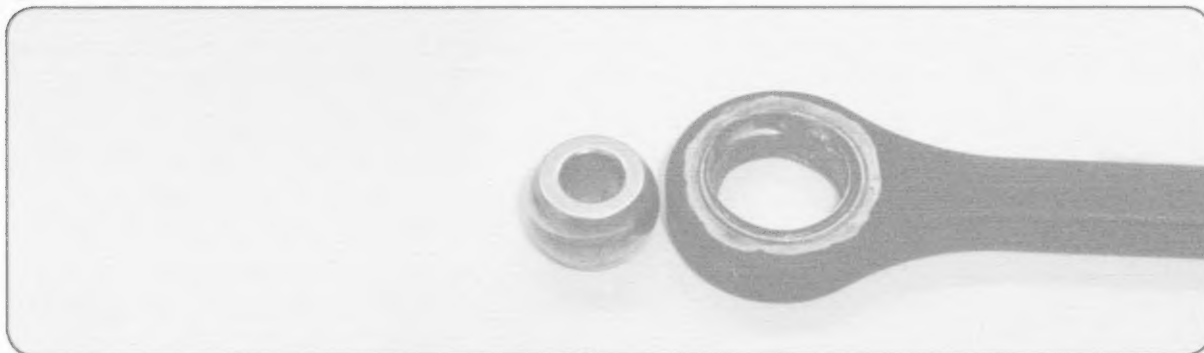
Tail Rotor Pitch

The pitch change rod end-bearing ball was found separated from the pitch link. The pilot reported that the tail rotor felt different upon landing, the pilot conducting a post flight inspection discovered the defect. An AME was dispatched to attend to the problem. Both pitch change rods were replaced and the helicopter was returned to service.

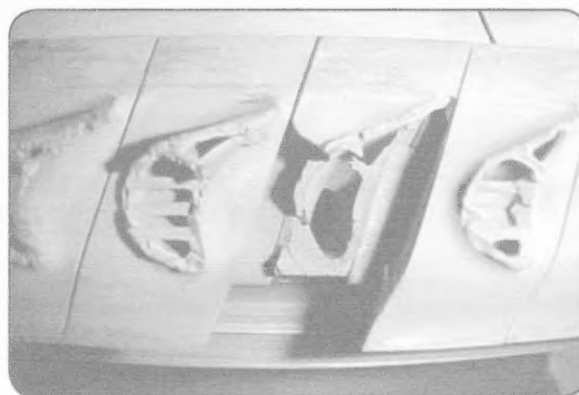
High Pressure Turbine (HPT) Stage 1 – Blade Release

There have been recent SDRs reporting the release of HPT Stage 1 blade(s). The blade(s) fractured beneath the inner blade platform. In several cases, replacement HPT blades were installed during the last shop visit in accordance with manufacturers Service Bulletin (SB) 72-101467 to upgrade to the latest turbine blade (BR700-715 series).

Rolls Royce is pro-actively addressing the engines at risk for the replacement of the HP1 turbine blades and is currently investigating all SDR reports to establish root cause of these blade fractures. Recently, Rolls Royce issued Worldwide Communication WW/20199/4/20 December 2007, addressed to All BR 715 operators.

Pending identification of root cause by the manufacturer, Transport Canada recommends that operators comply with the most recent Rolls Royce Service Bulletins. ✖

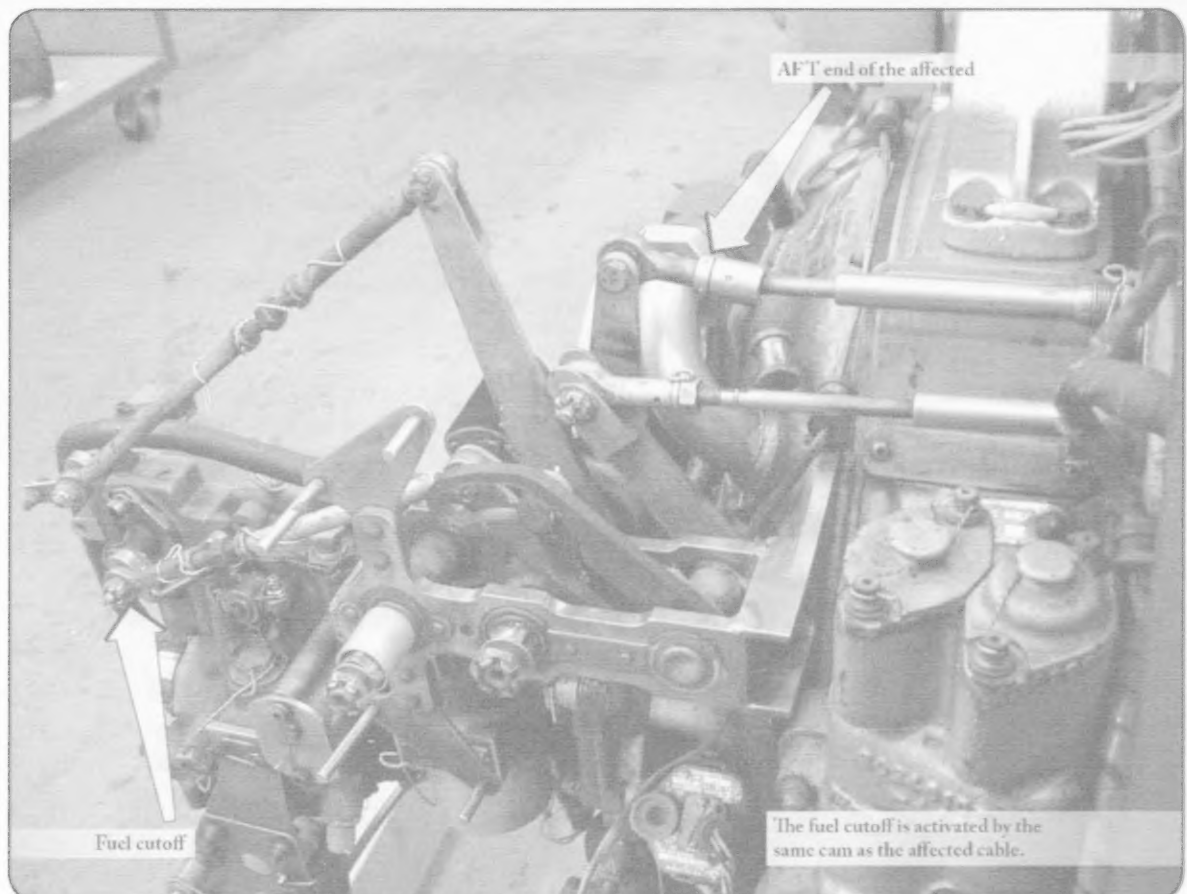
While carrying out a post flight shutdown, the No. 2 Condition Lever would not feather the propeller or shut off the fuel supply (via a cam mechanism) to the subject engine. As a result, the emergency shutdown “T” handle had to be used. Further investigation revealed the No. 2 Teleflex cable had become unscrewed near the bearing. The operator was unaware that the cable could become unscrewed at this location, as there is no visual indication (lockwire or witness paint). Another aircraft in the operator’s fleet was also found to have a partially unscrewed Teleflex cable.

The Teleflex cable controls the positions of the propeller governor and the engine fuel cutoff. The propeller governor is initiated first, and then through a cam mechanism before the fuel cutoff is initiated.

Unfortunately, human factors were the primary cause of this event. ✖

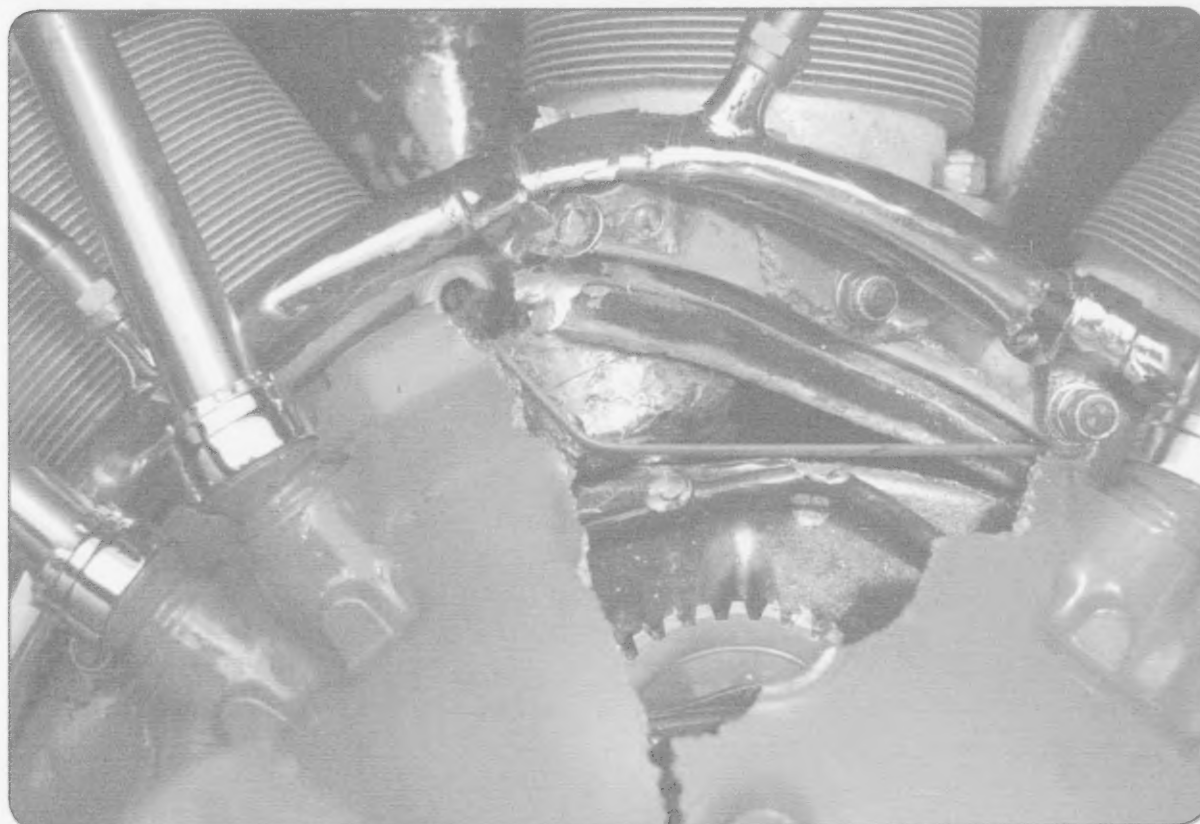
Crankshaft Counterweight Engine Failure

About 20 miles NW of its destination, a Beech D18S floatplane had just descended to avoid some adverse weather, when suddenly a violent vibration shook the aircraft. The left engine momentarily ran extremely rough and then abruptly quit. The situation was indeed serious. The critical engine failed and the propeller was neither rotating nor in "feather position", thereby causing significant aerodynamic drag. The pilot was barely able to maintain airspeed of 80 knots with maximum power on the right engine and was forced into a 25-knot downwind situation in order to make the nearest lake.

In the process of dismantling the failed engine, the AME discovered a large portion of the crankshaft forward counterweight had broken free and was lying in the cavity of No. 1 cylinder. It appeared that the failed counterweight then took out both No. 1 & 2 cylinders causing the abrupt engine stoppage and severe internal engine damage.

The engine was sent to the Transportation Safety Board of Canada (TSB) to determine the root cause of the failure. Because of severe internal damage, the engine had to be sawed into several sections before investigation was possible. Initial visual examination revealed that the forward counterweight assembly had separated from its crankcheek. The liberated counterweight caused severe and extensive damage to the cylinder skirts, connecting rods, pistons and crankcase. The No. 1 cylinder assembly had completely separated from the crankcase. Pounding damage from interaction between the rotating crankshaft and the separated counterweight had so deformed the front section of the crankcase that the screw heads from the rocker oil manifold were imprinted onto the crankcase.

Further investigation of the failed crankcheek revealed that it had fractured as a result of fatigue cracking, beginning at a drilled rivet hole that retains the counterweight to the crankcheek. It was determined that this fatigue crack (low stress/high cycle) was in existence for an extensive

period of time; long before the last time between overhauls TBO (250 hours ago). Evidence revealed that the rivet hole had been drilled with a dull drill bit during the initial manufacturing process. The rough edges had eventually created a stress riser leading to a fracture, which did not occur until many years later.

The design of this crankshaft makes crack detection on the specific crankshaft cheek rivet bore extremely difficult. Magnetic Particle Inspection (MPI) will almost certainly not detect cracks in this case, because the origin area in question is hidden by the inner and outer pieces of counterweight material. Ultrasonic inspection may be an option if an approved procedure were developed that would reliably detect cracks in the subject area. Alternatively, disassembly of the front counterweight assembly would be necessary to reliably inspect for cracks initiating from the rivet bore in crankshaft cheek, but may not be practical or may introduce new issues upon reassembly. It is now clear that it would be impossible to properly carry out an MPI inspection in this area. ✖
